Fatigue Failure Analysis of Enhanced 35N LT®

Lawrence Kay, Raymond Bouthot

Fort Wayne Metals Research Products Corp., Fort Wayne, Indiana, USA

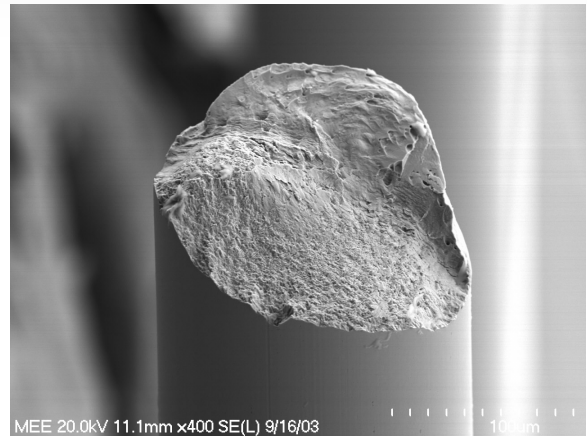
Figure 3

Figures 1 and 2 are faces A & B of the 200 Ksi fracture failure. They are typical failure images of the ASTM F 562 material. The failure progressed through the wire until the applied stress caused the remaining section to fail by ductile fracture, characterized by the dimpled microscopic fracture morphology. Radial markings on the fatigue fracture area of each fracture indicated a distinct single initiation site at or near the surface of the wire.

Figure 3: Fracture Face A, ASTM F 562, 200 Ks, Sample 3 (magnification 400X)

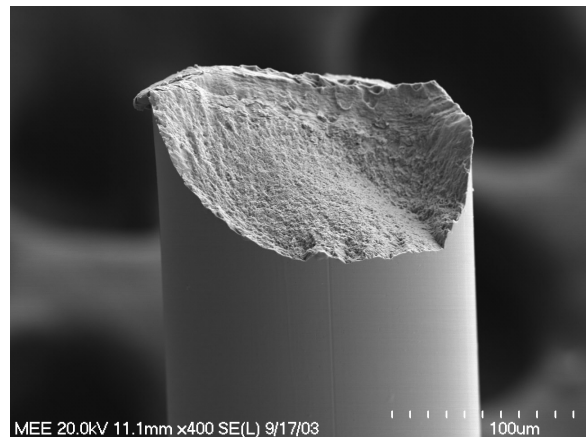
Figure 4

Figure 4: Fracture Face B, ASTM F 562, 200 Ksi, Sample 3 (magnification 400X)

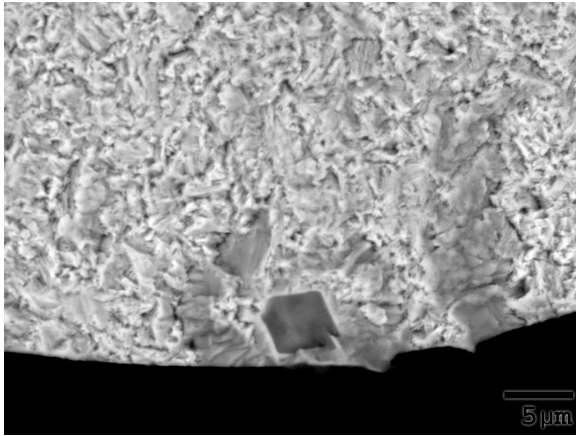
Figure 5

A large, dark (by BEI) angular inclusion was present at each fatigue initiation site. The inclusions ranged from about 2 µm across to about 5µm across. The following image is typical of the fracture faces of the ASTM F 562 material demonstrating the initiation site at the inclusion site near the circumference of the wire surface.

Figure 5: Fracture Face B, ASTM F 562, 200 Ksi, Sample 3 (magnification 3000X)

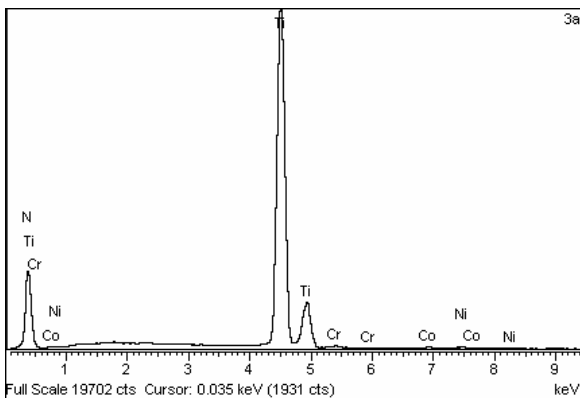
Figure 6

EDS analysis of the dark inclusions at the fatigue initiation sites detected primarily titanium and nitrogen, Figure 6. This composition indicated that the inclusions were titanium nitride. The angular shape of the inclusions is also consistent with titanium nitride particles.

Figure 6: EDS spectrum for typical fracture origin inclusion, sample 3 fracture face A.

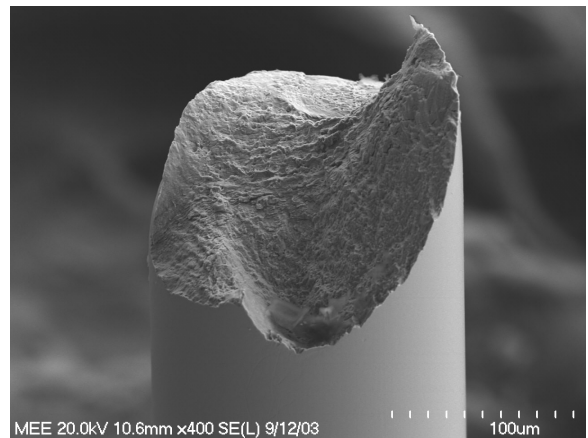
Figure 7

Figures 7 and 8 are faces A & B of the 200 Ksi fracture failure. They are typical failure images of the 35N LT® Alloy material. Faint beach marks, secondary cracking, and/or striations characteristic of the fatigue failure mechanism were observed for each of the fractures. Radial markings on the fatigue fracture area of each fracture indicated a primary fracture origin area at or near the surface on one side of the wire. For some samples, shallow ratchet marks or larger jogs in the fracture plane suggested that fatigue may have initiated at multiple locations.

Figure 7: Fracture Face A, 35N LT® Alloy, 200 Ksi, Sample 3 (magnification 400X)

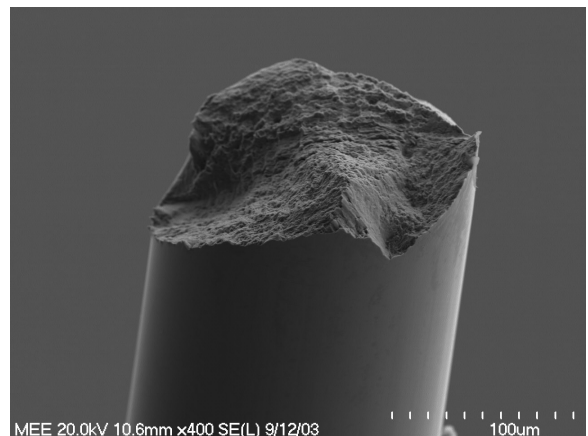
Figure 8

Figure 8: Fracture Face B, 35N LT® Alloy, 200 Ksi, Sample 3 (magnification 400X)

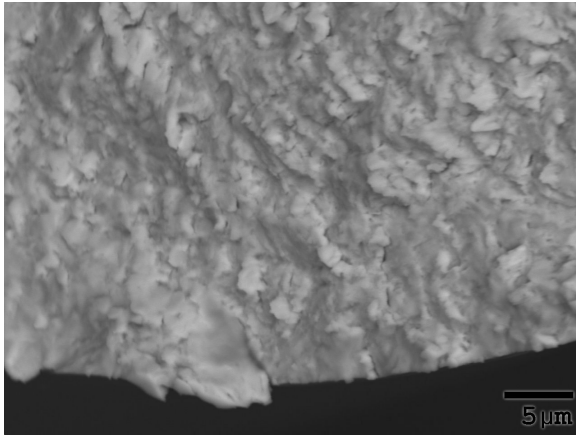
Figure 9

Figure 9: Fracture Face B, 35N LT® Alloy, 200 Ksi, Sample 3 (magnification 3000X)

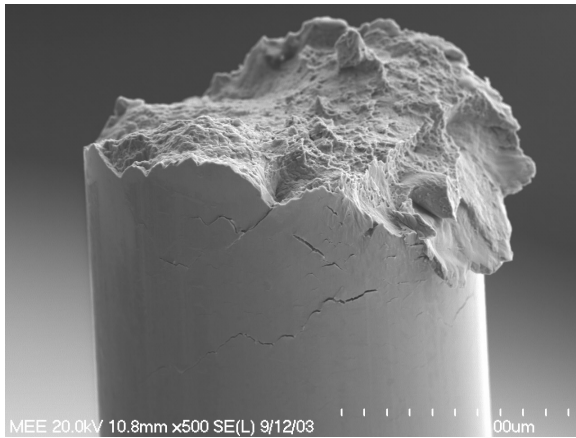
Secondary cracks were observed on three of the samples on the side of the wires near the fracture origin sites. These cracks were likely separately initiated fatigue cracks. Figure 10 is an example of a secondary crack. The lack of inclusions results in these multiple cracks indicating that the material has failed at several locations due to the consistency of the material.

Figure 10: Fracture Face A, 35N LT® Alloy, 250 Ksi, Sample 1 (magnification 500X)

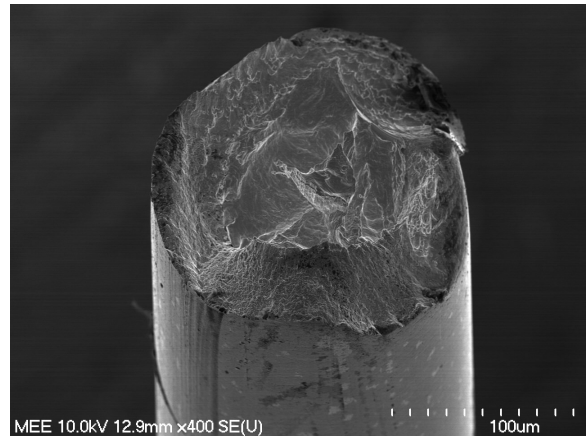
Figure 11

Each of the fractures exhibited radial markings indicative of a single fracture initiation site at or near the surface of the wire. The microscopic fracture features in the origin area for each wire consisted of a ridged texture with fatigue striations. This fracture morphology is characteristic of a fatigue fracture mechanism. The fatigue fracture propagated across over one half of the cross section of each wire. The remainder of the cross section for the tube section had a dimpled fracture morphology that was characteristic of a ductile fracture mechanism.

Figure 11: Fracture Face A, ASTM F 562 DFT, 200 Ksi, Sample 4 (magnification 400X)

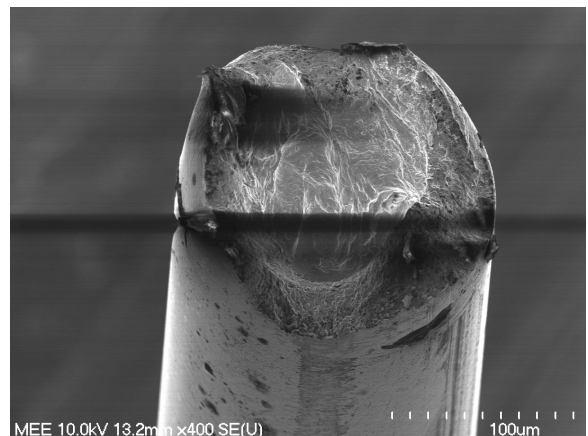
Figure 12

Figure 12: Fracture Face B, ASTM F 562 DFT, 200 Ksi, Sample 4 (magnification 400X)

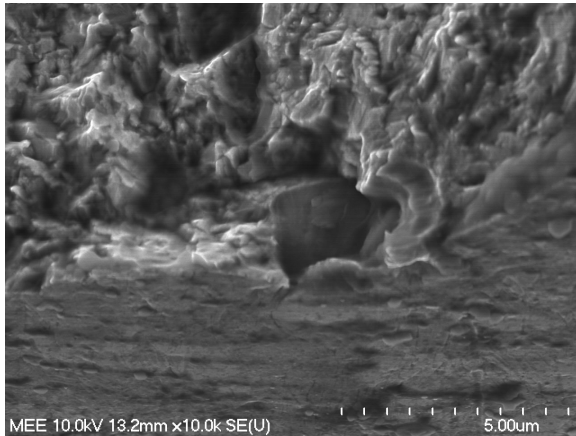
Figure 13

Figure 13: Fracture Face B, ASTM F 562 DFT, 200 Ksi, Sample 4 (magnification 10,000X)

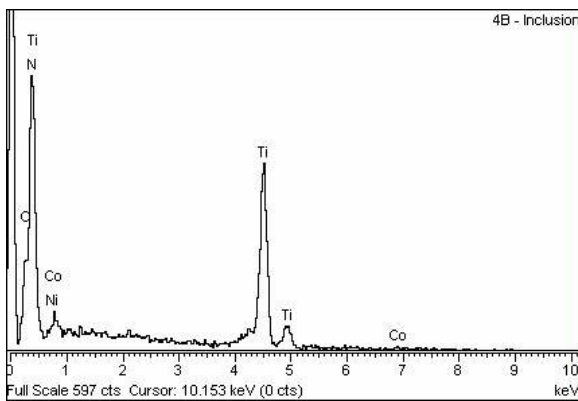
Figure 14

Figure 14: Fracture Face B, ASTM F 562 DFT, 200 Ksi, Sample 4

A nonmetallic inclusion was present at the fracture origin for each wire. EDS analysis of all the inclusions at the fracture origins detected primarily titanium and nitrogen.. The inclusion size at each fracture origin area is shown in the following table.

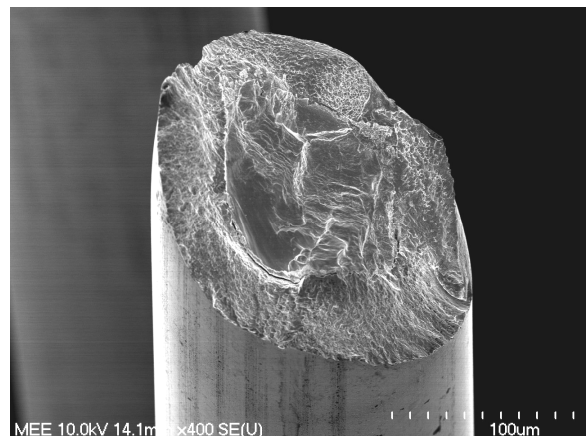
Figure 15

Twelve samples of fractured 35N-DFT-28Ag were submitted for fracture evaluation by scanning electron microscopy (SEM). The fracture mechanism for each sample was fatigue fracture. The fractures for all of the samples were oriented on a slightly oblique plane, which suggested that the fracture stresses were due to a combination of bending and torsional forces. Many of the samples appeared to have multiple fracture initiation sites. Most samples had secondary cracks in the wire surface near the fractures. The fracture for each of the samples occurred without significant gross plastic deformation, such as necking or bending. The microscopic fracture morphology for most of the tube cross section was typical of a fatigue fracture mechanism. Significant fracture features were typically not observed for the silver cores. No evidence of inclusions were detected at the fracture origins for any of the samples.

Figure 15: Fracture Face A, 35N LT DFT, 200 Ksi, Sample 4 (magnification 400X)

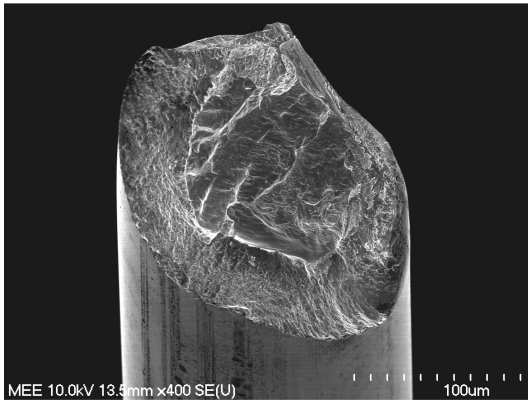
Figure 16

Figure 16: Fracture Face B, 35N LT DFT, 200 Ksi, Sample 4 (magnification 400X)

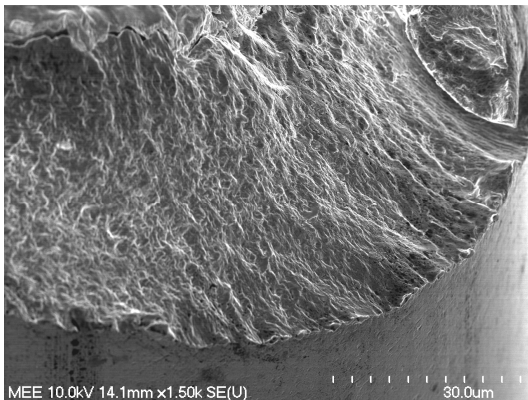
Figure 17

Figure 17: Fracture Face A, 35N LT DFT, 200 Ksi, Sample 4 (magnification 1500X)

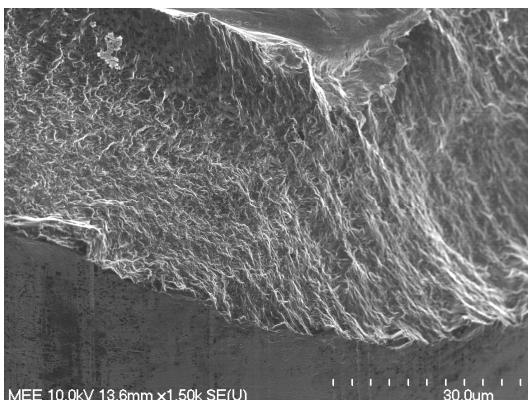
Figure 18

Figure 18: Fracture Face B, 35N LT DFT, 200 Ksi, Sample 4 (magnification 1500X)
